MTL TR 90-54

FORMATION OF CONTROLLED ADIABATIC SHEAR BANDS IN AISI 4340 HIGH STRENGTH STEEL

November 1990

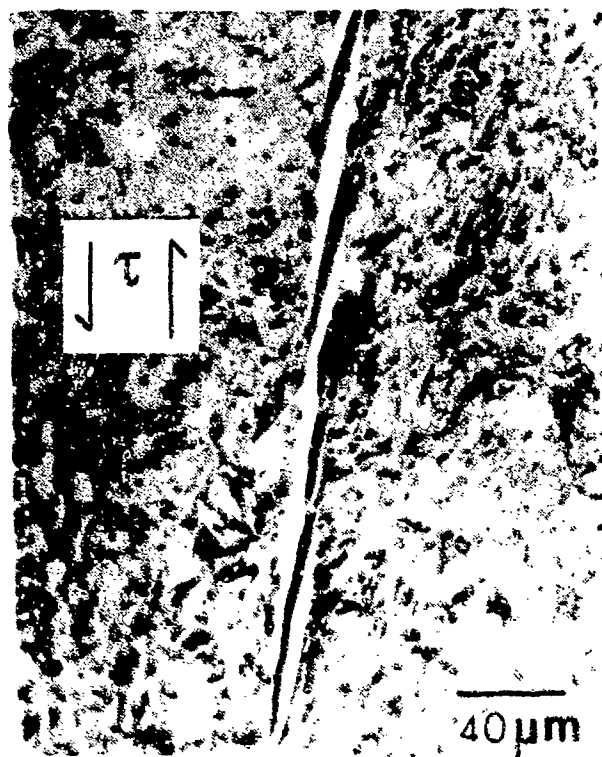
Figure 3. Tension cracks produced in the specimens upon unloading. Original loading direction is noted. Normalized at 925°C.

Some specimens undergoing larger displacements with full shear band deformation often exhibited cracks along the shear bands; these cracks along shear bands are common. Since their orientation with the original imposed shearing direction (see Figure 3) would close the cracks and not open them, it is concluded that the cracks must have formed after the removal of the imposed shear stresses. It is also indicative of the increased hardness usually associated with the shear band material after testing.
